4.4 Exchangers

All Heat Exchanger Data was reviewed and update for all the exchanger during this Shutdown. Any gasket changes and torque procedure revisions were documented in the 2 binders labeled D&R 1Q 2007 S/D Heat Exchanger Gasket Info and Updates.

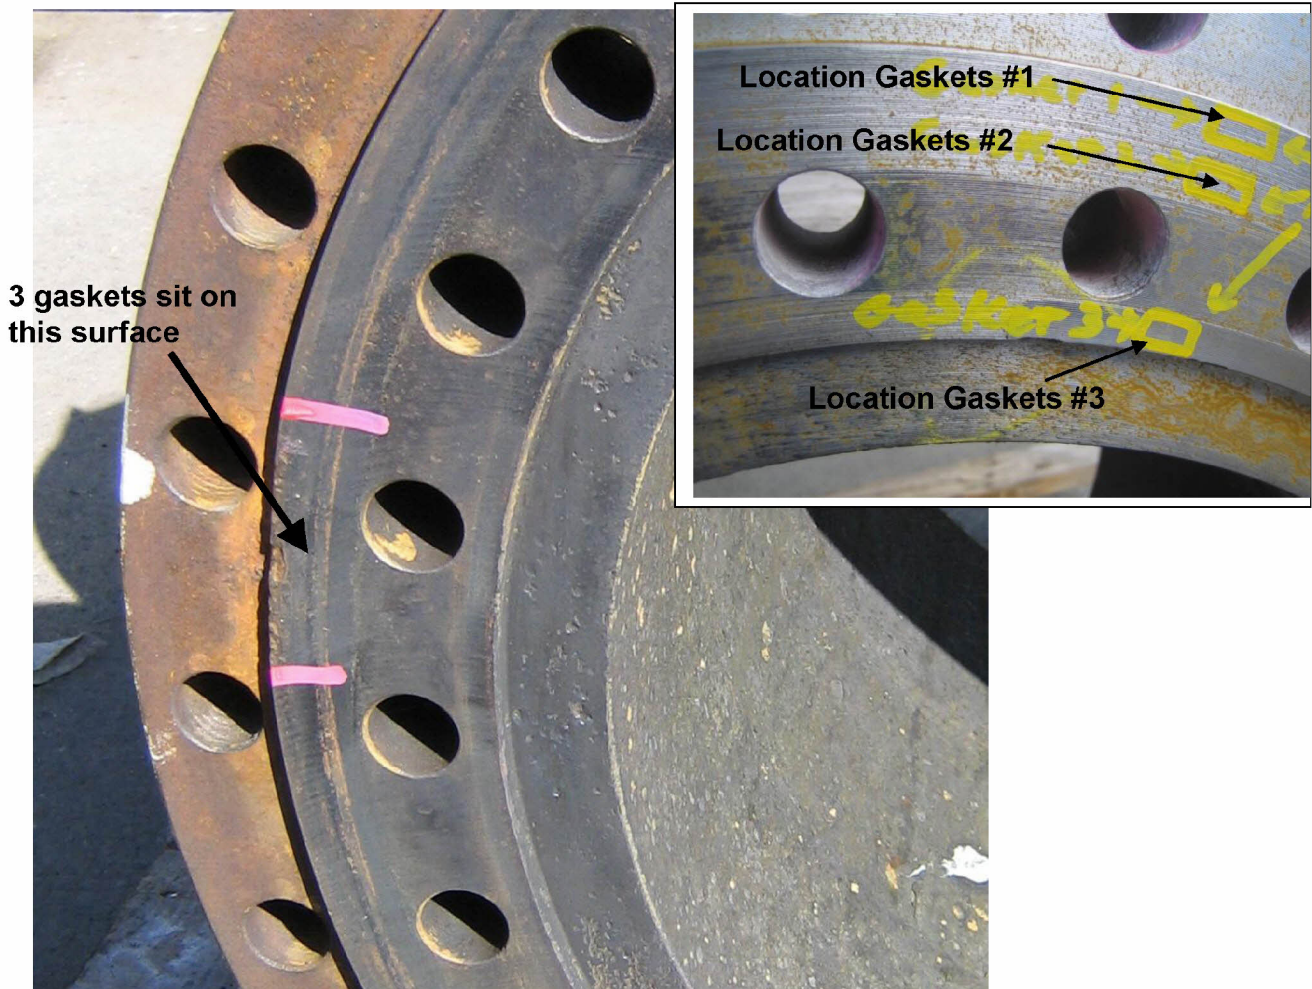
These exchangers were found to have significant gasket surface corrosion on the internal components. In addition, a few gasket surfaces were damaged by the contractor during dismantling. The following work was completed:

E-1101B – Weld built and machined the tail pipe mating spool gasket surface (side with 3 gaskets), weld built and machined the shell pot gasket

surface (Shell Pot – Tail Pipe Mating Spool), skim cut the channel inlet flange, and skim cut the shell pot gasket surface (Shell Pot – Shell).

Figure 4.5.2.1. Example of gasket surface damage on E-1101B tail pipe mating spool.

All of the tail pipe mating spool gaskets were changed from clad to CamPro. Heat Exchanger Data Base was updated. The largest of the gaskets must be centered on the shell pot before the tail pipe mating spool is installed. If not centered properly, it can drastically reduce the effective sealing area on the gasket. On E-1101A (suffered a leak on-the-run), the gasket was not centered last time it was installed, allowing only 1/2 of the 3/8" wide gasket to be clamped. This may have contributed to the leak.

RECOMMENDATION E-1101 A-D: Ensure that the shell pot drain lines are blown down every shutdown. When bundles are disassembled, ensure that the bundles are reinstalled in the correct orientation and that the gaskets are centered on the tail pipe mating spool.

RECOMMENDATION E-1101 A-D: Change the outside diameter of Expansion Joint Gasket O (tail pipe spool – shell pot) from 22 7/8” to 22 15/16”. This change should help with the centering issue mentioned above. It may be prudent to order a spare gasket in the old size just in case the new gasket does not fit.

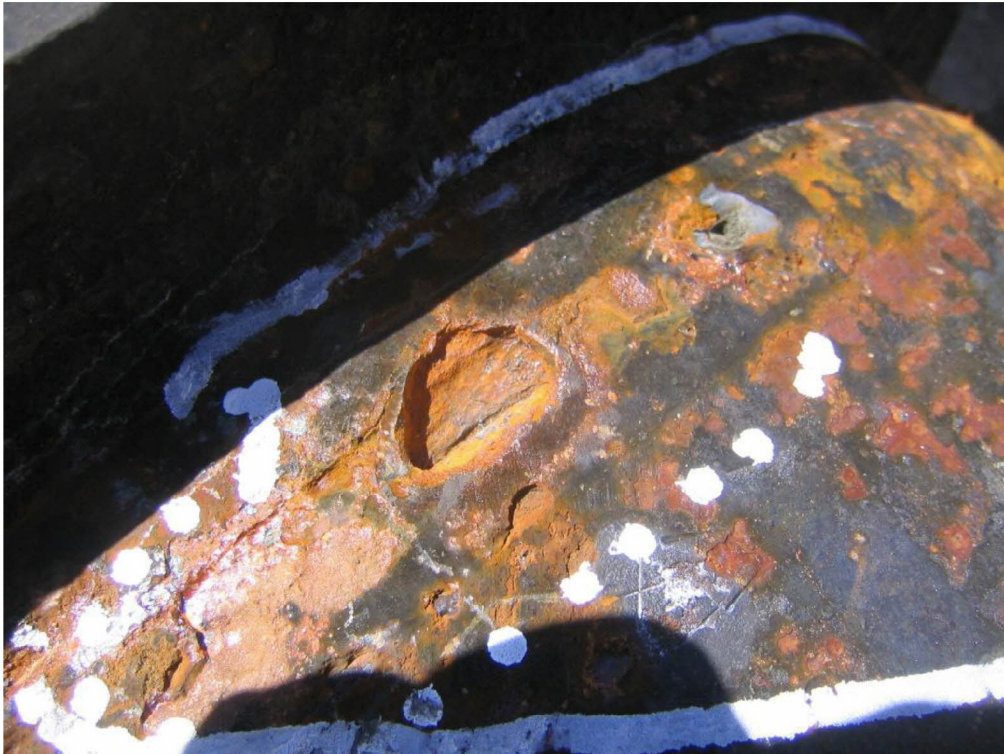
The bellows in E-1101D was replaced due to severe corrosion, with pits greater than 0.40". The bellows was last replaced in 2002, so all of the corrosion occurred in the last 4-5 years. We found that the continuous drain on the shell pot was plugged, allowing water and other corrosives to sit in the shell on the outside of the bellows.

To replace the bellows, significant weld build was required on the outlet flange due to pitting. The excessive welding warped the holes in the outlet flange, causing us to have to bend the studs to attach the tail pipe mating spool. We did not have enough time to acquire a new forged outlet flange.

Figure 4.5.2.2. Bellows corrosion on E-1101 D.

RECOMMENDATION E-1101D: Replace the forged flange on the floating head bellows outlet for E-1101D. The outlet flange is distorted from welding.

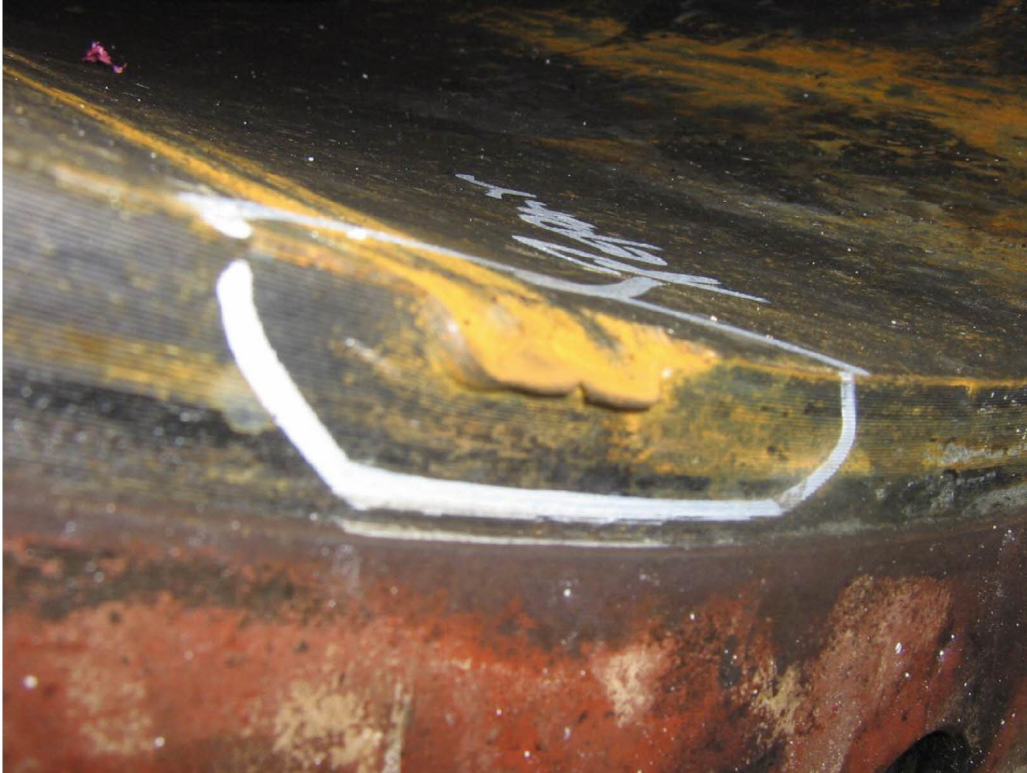
Some damage was noted on the shell of E-1102 A and C from bundle removal. The skids of the bundle were drug along the shell causing severe burrs which were draw filed off.

Figure 4.5.3.1. Damage to the shell gasket surface on E-1102B.

RECOMMENDATION: Ensure that contractors are aware of the damages that can occur from improper bundle removal.

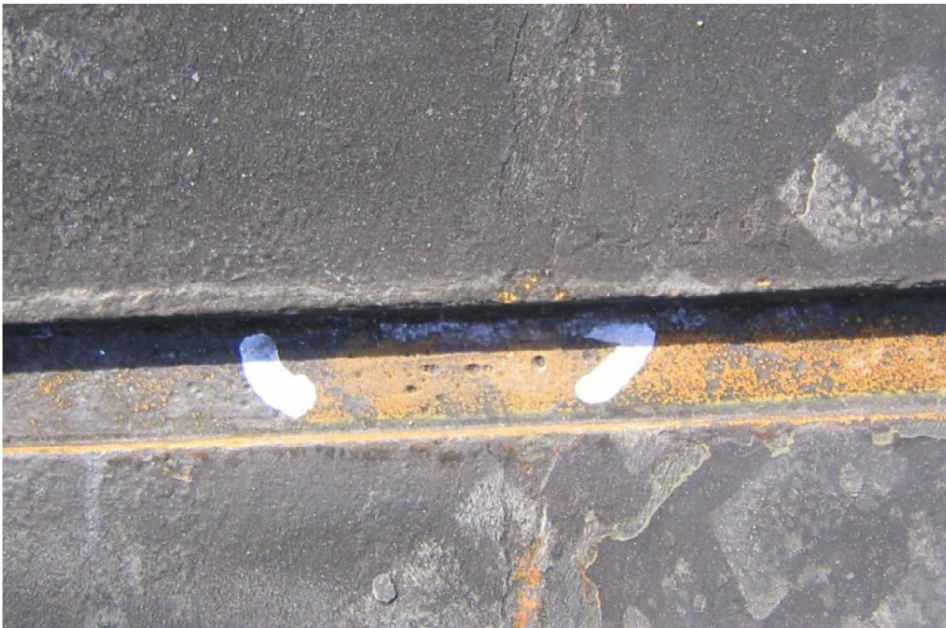
A and B bundles were removed, cleaned, inspected, and reinstalled. There were no repairs and no bundle problems were reported by inspections. There was some minor pitting noted by inspections on the channel cover gasket surface on E-1107 B. No repairs were done because the pitting was minor and did not compromise more than 50% of the gasket surface.

Figure 4.5.8.1. Pitting noted by inspections on E-1107B channel cover gasket surface.

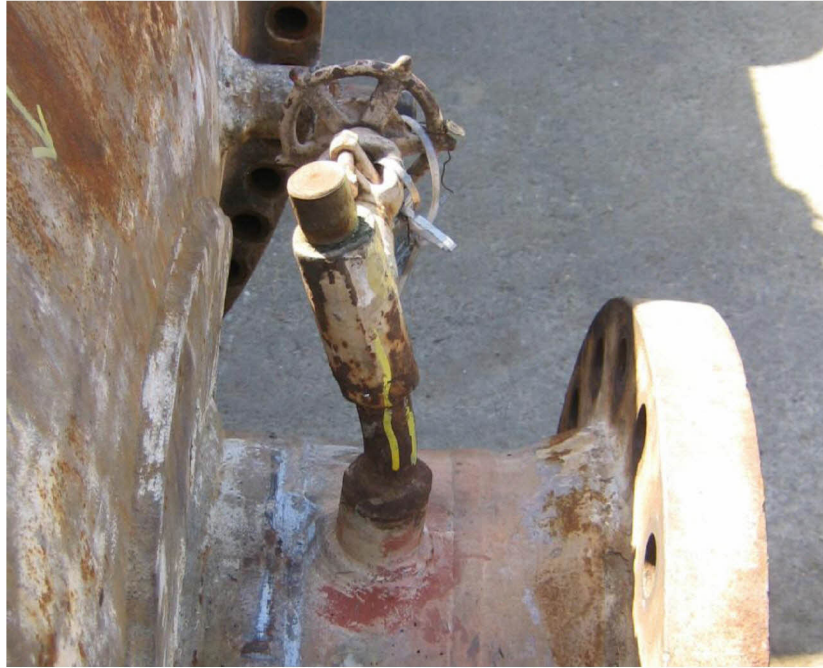
A 3/4" bleeder on the channel inlet was replaced in-kind on E-1107B because it was bent.

Figure 4.5.8.2. Bent $\frac{3}{4}$ " bleeder valve on E-1107B channel.

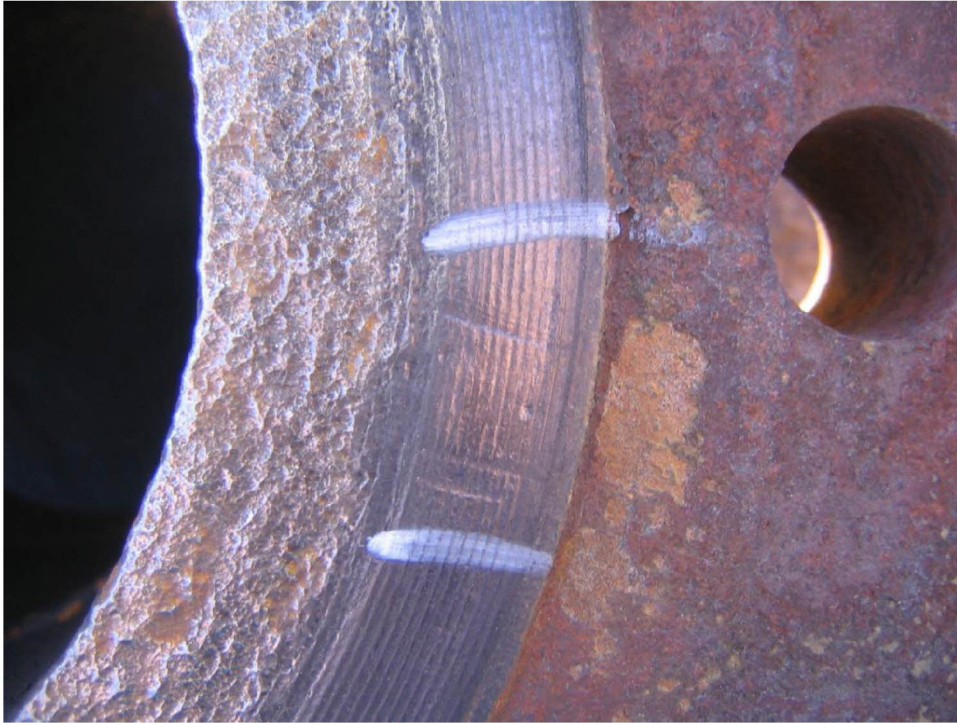
A TAW was written to skim cut one of the channel nozzles gasket surfaces. This was denied because the blemishes in the gasket surface were not deep enough to warrant taking a skim cut.

Figure 4.5.10.1. Gasket surface damage to channel nozzle flange.

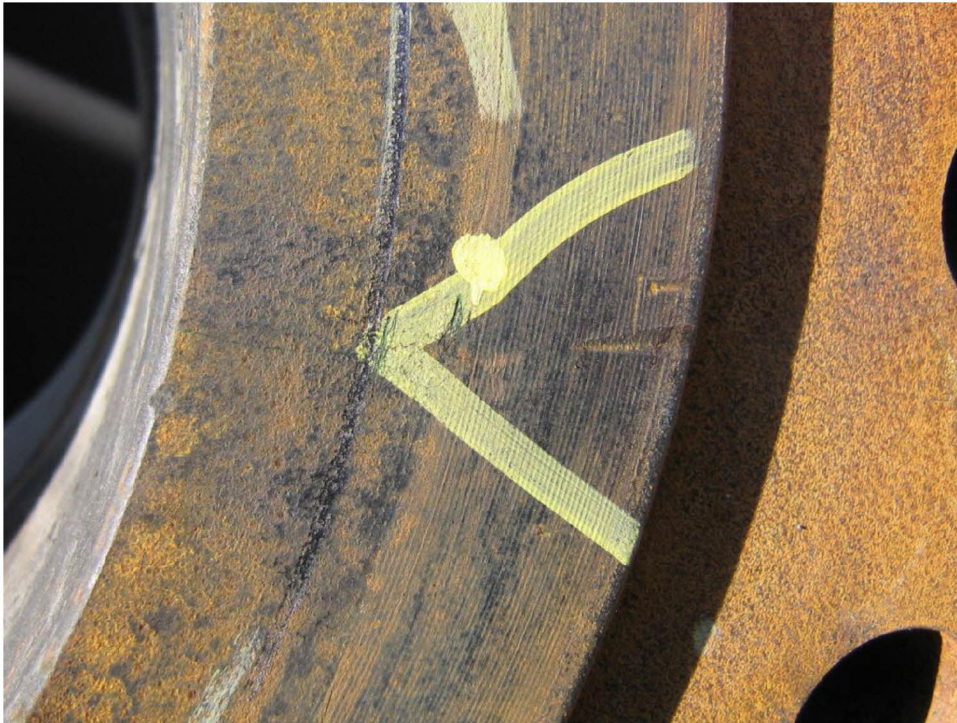
During installation, the contractor damaged the gasket surface on the channel nozzle of E-1110B. We placed the gasket on the surface of nozzle and took extensive measurements. The damage only crossed ~43% of the gasket surface, so no repair was performed.

Figure 4.5.11.1. Gasket surface damage to channel nozzle on E-1110B.

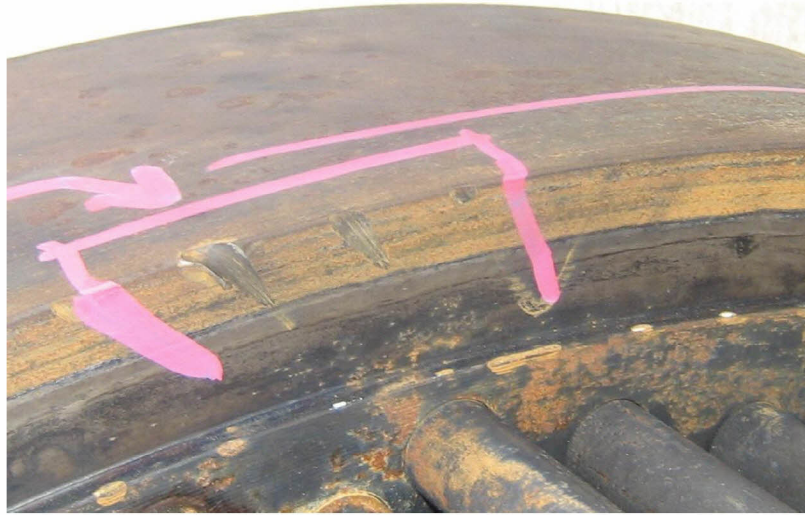
Bundle was removed, cleaned, and inspected. No problems were reported by inspections for the channel, shell, or channel cover. We repaired one gouge in the back of the fixed tubesheet that was caused by

contractor error. The spot was machined off by Benicia Fab. The bundle tubes were in good shape.

Figure 4.5.12.1. Photo of the damages to the tubesheet on E-1111.

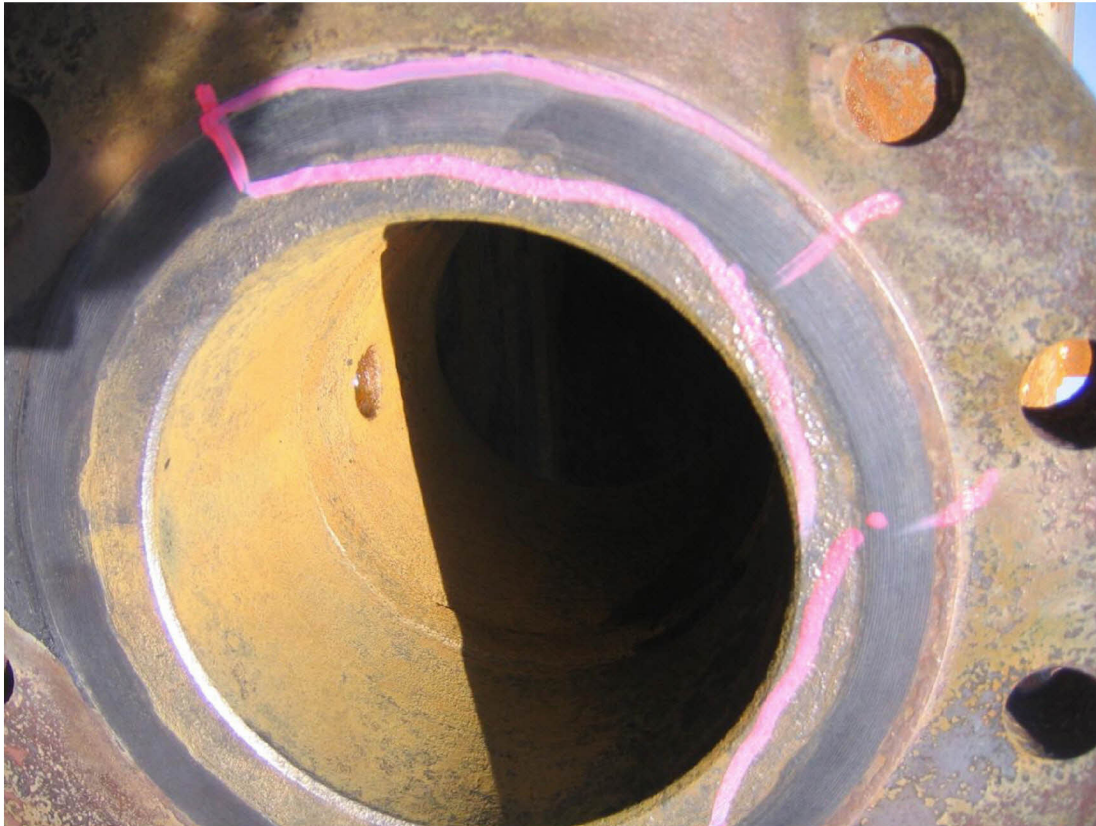
Bundle was removed, cleaned, and inspected. Inspections issued a TAW to repair the channel nozzle flange surface. This was denied because both the channel flange surface and the mating flange in the field had no noticeable damage. The TAW was written because it appeared that process had been leaking.

Figure 4.5.15.1. E-1114 gasket surface that was written up by inspections.

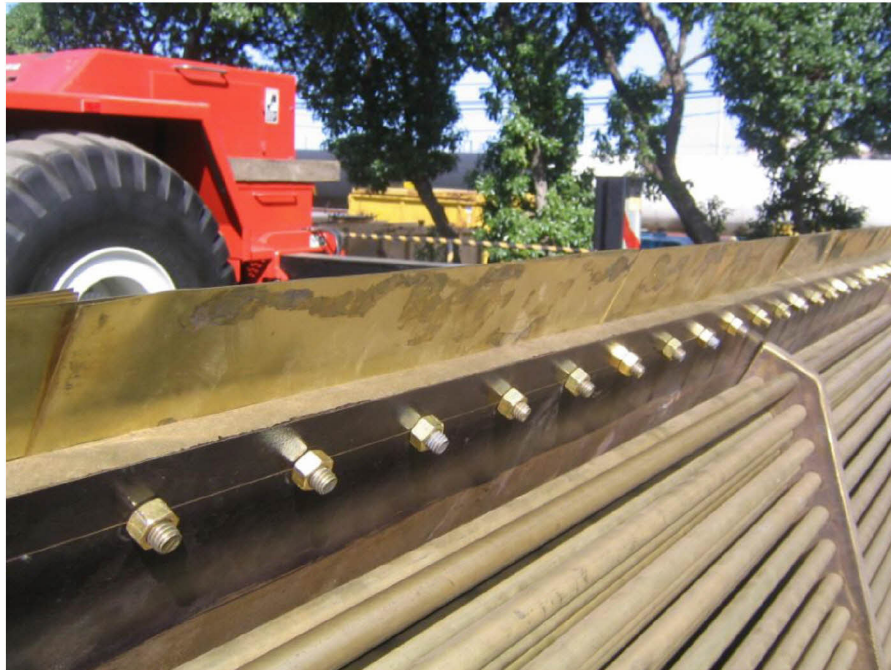
Figure 4.5.20.1. Layered lamiflex for E-1160A/B

The lamiflex for the exchangers was supplied in 2' single strips, rather than a continuous strip with 8 layers. We decided to install the lamiflex in layers of 4 that were overlapped to create 8 layers total. This should be replaced with one continuous strip next time the bundles are pulled.

RECOMMENDATION: Install one continuous strip of admiralty brass lamiflex next time the bundles are pulled.

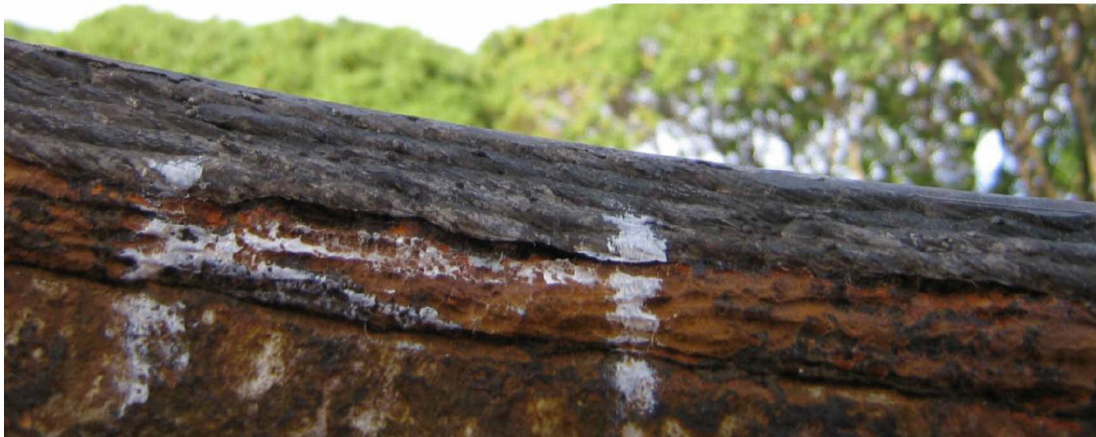
The floating head cover showed significant undercut corrosion near the flange. This area had been previously repaired in 1988 with a Monel overlay. We ground out the corrosion and weld built with the same Monel weld procedure. Because the flange was thick, the weld overlay only replaced material that had been machined deeper than 3/8". It might be prudent to order a new floating head for next shutdown.

Figure 4.5.21.1. Undercut corrosion on E-1161.

RECOMMENDATION: Replace the floating head or develop a long term replacement plan.

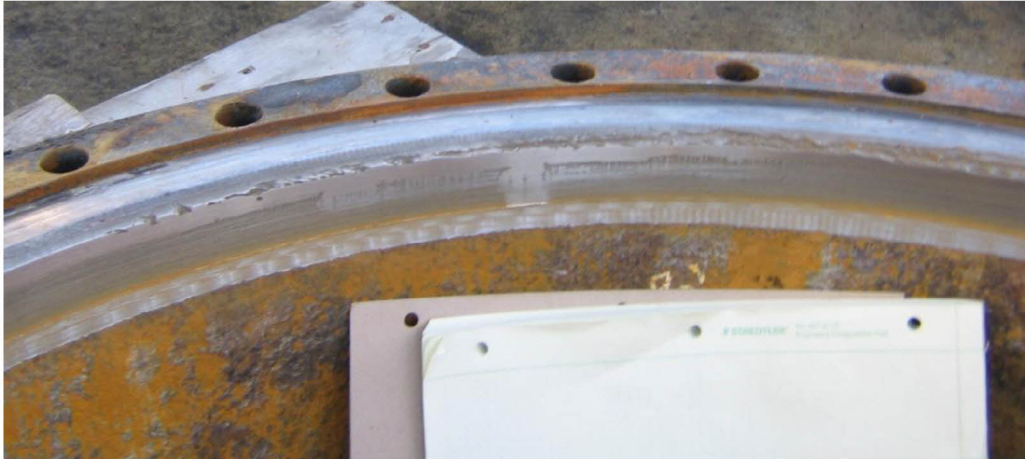
Figure 4.5.21.2. Machining and weld repair on E-1161 floating head.
